Investigation of the Effects of Manufacturing Variations and Materials on Fatigue Crack Detection Methods in Gear Teeth

Jeffrey A Wheitner and Donald R. Houser
The Ohio State University
Columbus, Ohio

January 1994

Prepared for
Lewis Research Center
Under Grant NAG3-1147

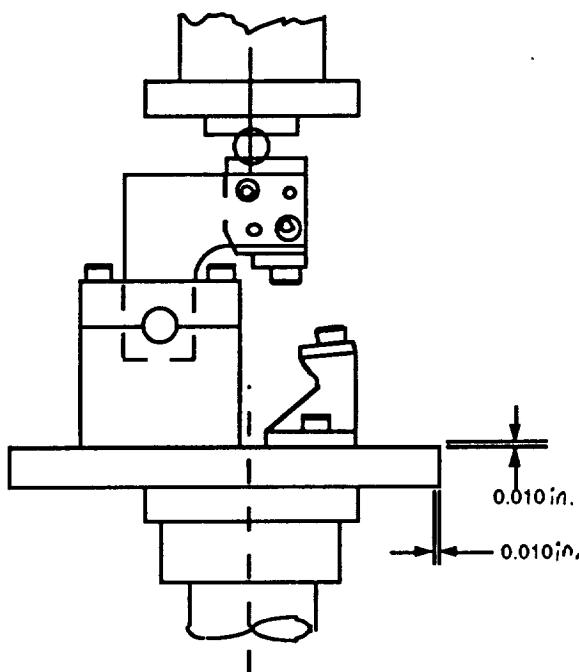
Figure 3.7 Fixture Deflections

The 9310 gears were initially tested at 16,000 lb. During this testing, a lateral deflection of the fixture of 0.010 in. was observed for tooth deflections of 0.010 in. as shown in Fig 3.7. It was unclear what was causing the transverse motion so a full kinematic analysis of the system was performed.

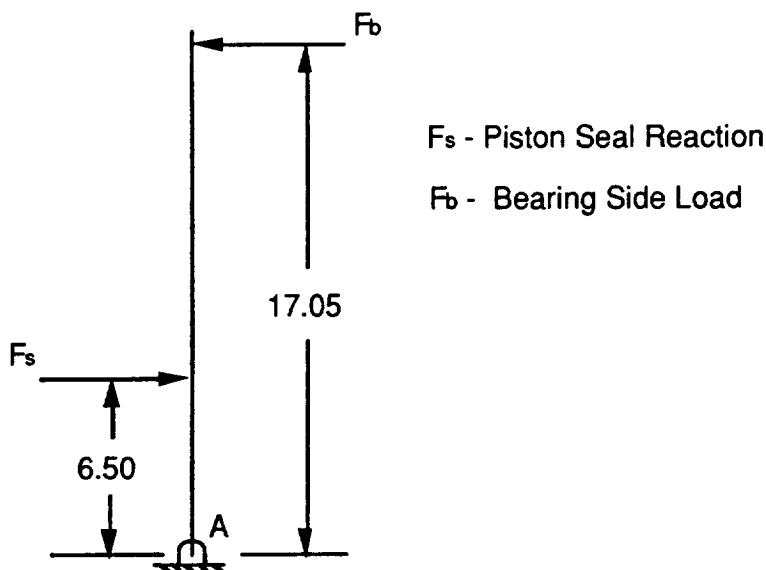
Figure 3.11 MTS Cylinder Seal Forces

Thus, the transverse bearing force at the gear axis is 107.5 lb. to the left. This force causes a side load on the actuator piston seals. Figure 3.11 shows the actuator piston AB and the horizontal reaction loads that occur during testing. The system is in equilibrium so the sum of moments about any point is zero. Summing moments about point A gives the piston seal reaction force.

According to MTS specifications, the actual side load is much lower than the 9000 lb. allowable side load. It was concluded that the MTS machine actuator piston seals were sufficiently compliant to allow lateral deflections to occur. According to engineers at the Materials Research Lab Inc., typical lateral deflections on their testing machine are approximately 0.010 -0.020 in and have negligible effects on the experiment. Because the side loads obtained from the SAE fixture loaded to 16,000 lb were less than 300 lb. and the maximum allowable side load according to MTS is 9000 lb., it was concluded that no damage to the machine was occurring, and the horizontal motion had no effect on the gear fatigue testing process.

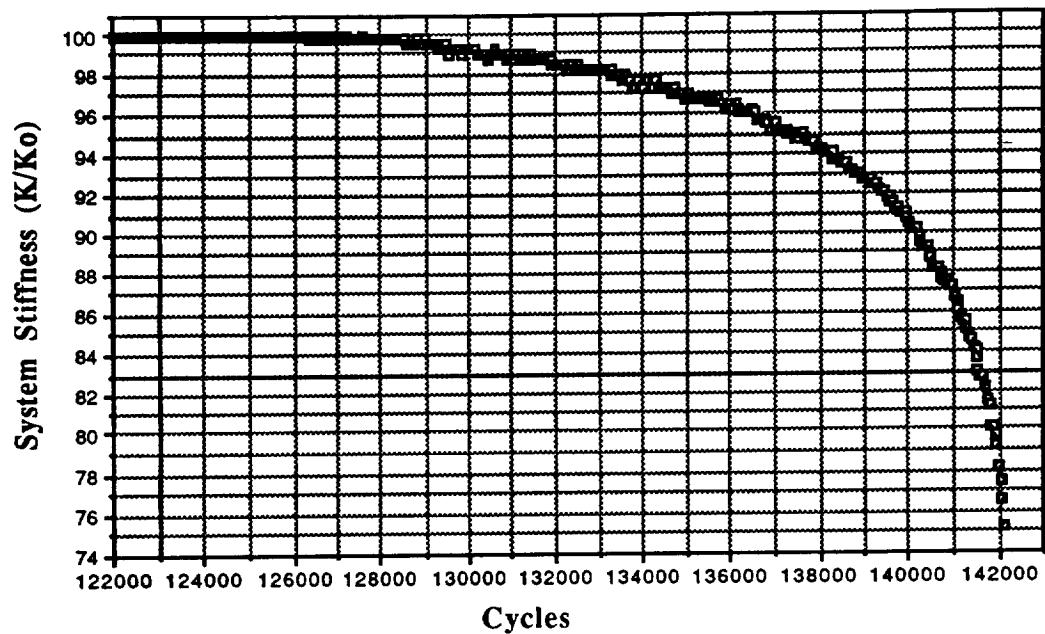
Figure 4.1 System Stiffness for 4118C at 170 ksi. Root Stress

The first plot, Fig. 4.1, is a plot of the system stiffness of a 4118 steel gear. This plot shows the typical shape of the system stiffness plot for all of the 4118 gears. All of the plots have been normalized to an initial stiffness of 100 to aid in comparison between different teeth and materials.

Figure 4.1 shows that the fatigue crack propagation life (126,000 to 142,000 cycles) of 16,000 cycles is only 11.2% of the total fatigue life for the tooth. This trend is continued in all of the materials tested. From Fig. 4.4 we see that the fatigue initiation life of the shot peened 9310 gear is approximately 70,000 cycles while the fatigue crack propagation life is only 2700 cycles, which is only 3.7% of the total fatigue life.

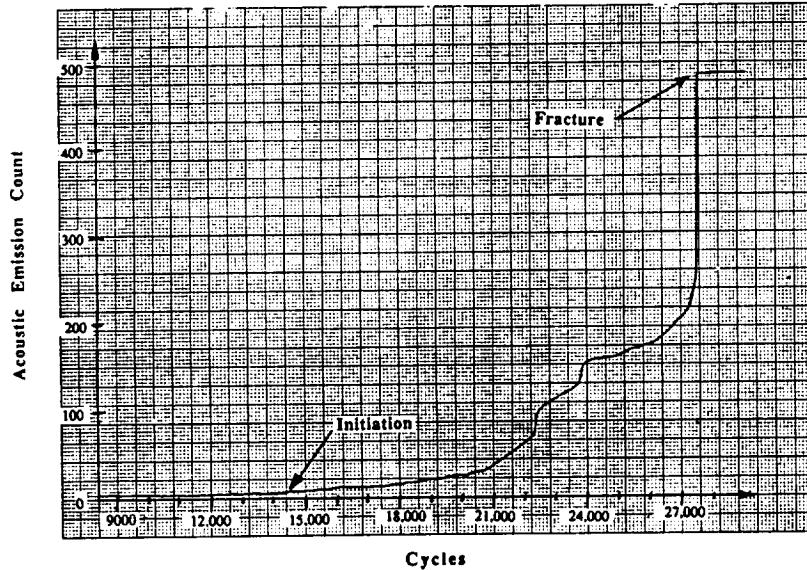
Figure 4.5 Acoustic Emission Count vs. Fatigue Life for 4118A Gear Tooth

As can be seen from Fig. 4.5, the emission count begins to increase at around 12,000 cycles. This appears to be when a discontinuity reaches a critical length and begins to propagate. The emissions continue at nearly a constant rate, producing a slope that is nearly constant. The crack reaches another critical state and the emission count rate increases causing an increase in the slope of the counts-life curve. This slope remains constant until the tooth is near fracture at which time the count rate and total counts increase dramatically until fracture.

The initially slow count rate could be a result of the gears being crowned. The crack begins in the middle, and propagates outward to the edges of the teeth. The crack

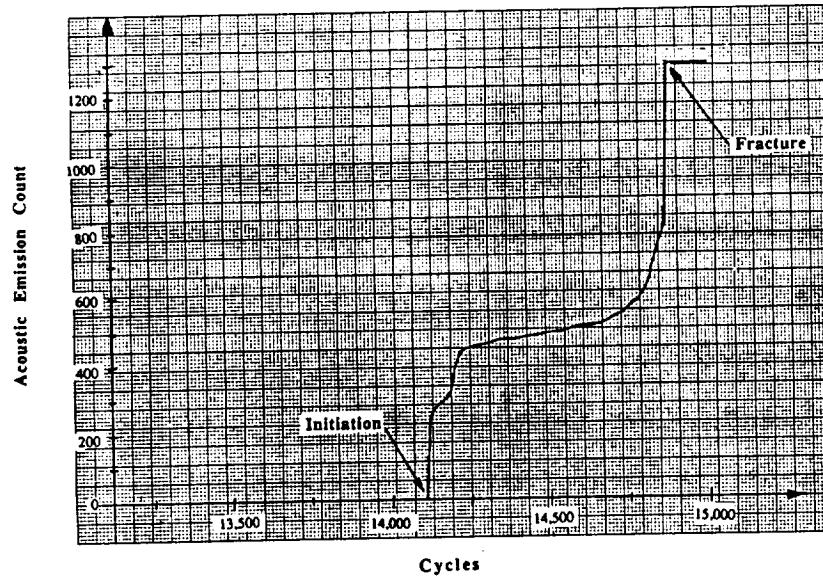
Figure 4.7 Acoustic Emission Count vs. Fatigue Life for a 9310 Gear Tooth

In the 9310 gears, the crack initiation mode was very different. As the gear reached a critical point, the gear instantaneously cracked across the thickness. When this happened, the gear let out an audible pop that sounded like the snapping of one's fingers. After this snap, the gear was inspected, and a crack was found that traversed across the entire face width. At the same time this pop was heard, the acoustic emissions rose very rapidly as shown in Fig. 4.7 and 4.8. After this abrupt jump in emissions the count rate decreases, and the curve flattens out during propagation. As the gear nears failure, the emission rate once again increases very rapidly until failure.

It is proposed that in the 9310 gears, a small discontinuity is growing below the surface near the case-core transition. After the crack reaches a critical value this sudden burst that occurs is the crack propagating rapidly to the surface. This failure is consistent with failures that occur below the surface of carburized steel in which the endurance limit of the core is much lower than the endurance limit of the case. The endurance limit is directly proportional to the hardness of the material in steels.

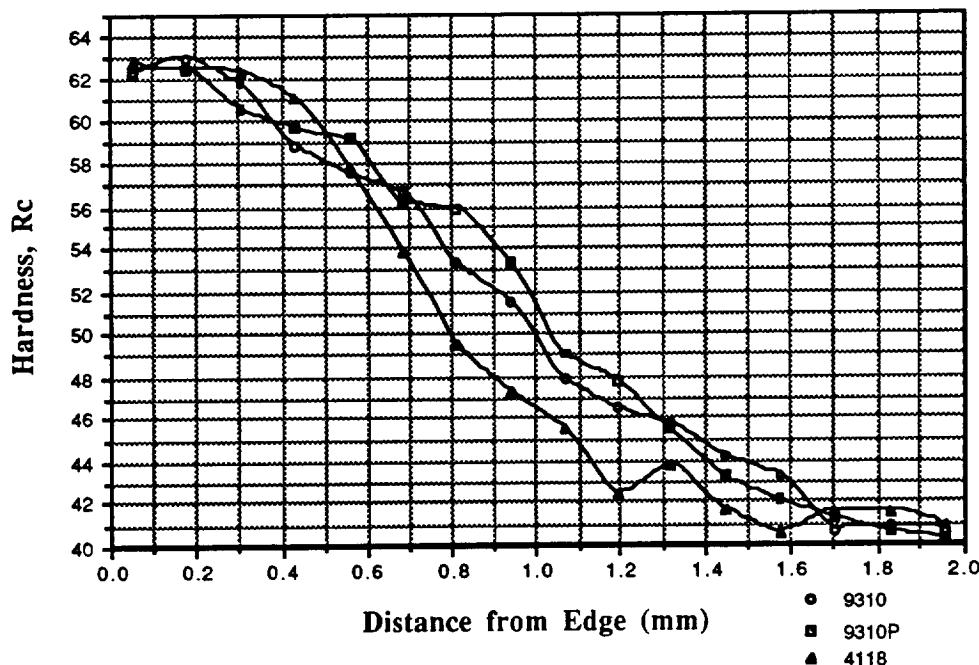
Figure 4.11 Hardness Profiles Near the Pitch Radius

The opposite situation occurs when the case and core have very different endurance limits as seen in Fig 4.10. This situation could occur when the core has a much lower hardness than the case layer. This appears to be the case in the 9310 gears, because after fracture, there is a very large shear lip along the final failure surface. There is also a very distinct cup and cone type failure along this edge, suggesting that the core is much softer and much more ductile than the case layer. The hardness profile for the 9310 gears at a location 2/3 of the tooth height from the tip, roughly the pitch line, are shown in Fig 4.11. These plots confirm the fact that the case layer is much harder than the core.

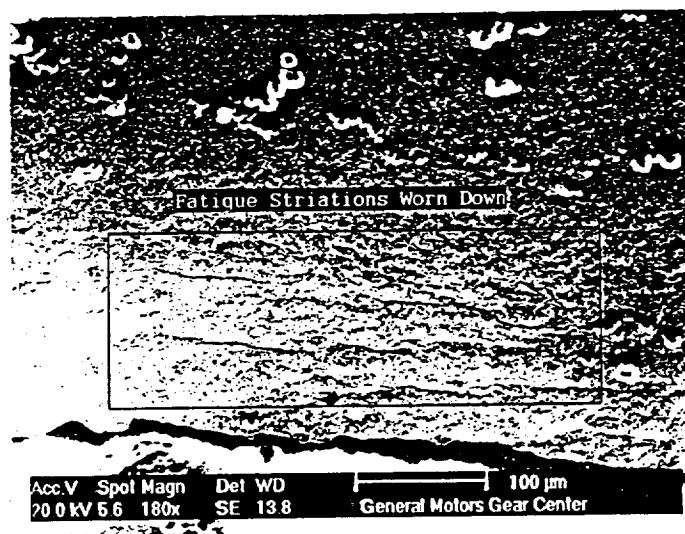
Figure 4.12 SEM of 9310 Gear Tooth Showing Fatigue Striations

Scanning Electron Micrographs (SEM) of two broken teeth from the 9310 gears reveal that the fatigue fracture area is very small, typically less than 1 mm, and transition from fatigue to rapid crack growth is very distinct. Two SEMs are shown below. The fatigue striations on the surface which have been worn down as the crack opens and closes are shown in Fig 4.12, and cup and cone type failure can be detected in Fig. 4.13.

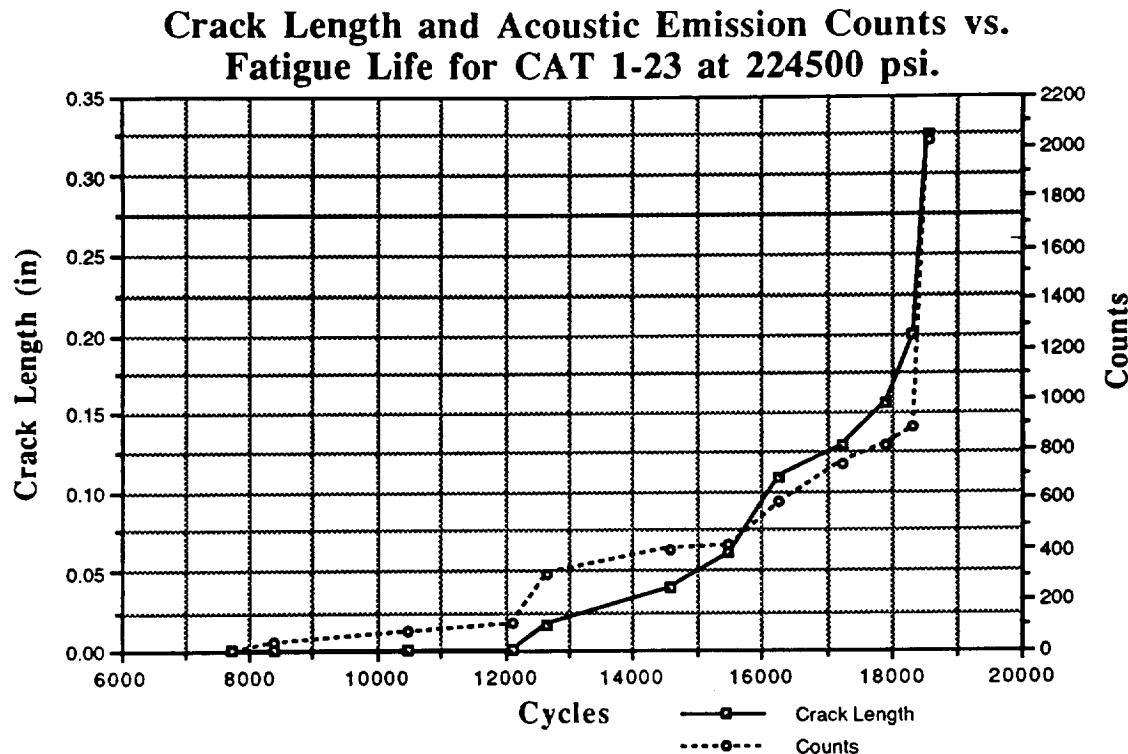
Figure 4.14 Acoustic Emissions and Crack Length as a Function of Fatigue Life

Acoustic emission works very well for predicting the onset of a fatigue crack in the 8620 steels. Figure 4.14 shows a plot of the acoustic emission counts and through-the-thickness crack depth as measured along the side of the tooth. The acoustic emissions begin roughly 4000 cycles before a crack is visible, thus giving ample warning that a crack has reached a critical length and is beginning to propagate.

The crack was examined using a 10x magnifying lens and the depth was measured along the side of the tooth with a scale. This probably is not a very exact measure of the area of the crack front, because the crack front is most likely circular shaped and deeper in the center, rather than straight across. The material at the crack tip in the center of the face width is under conditions nearly consistent with plane strain which

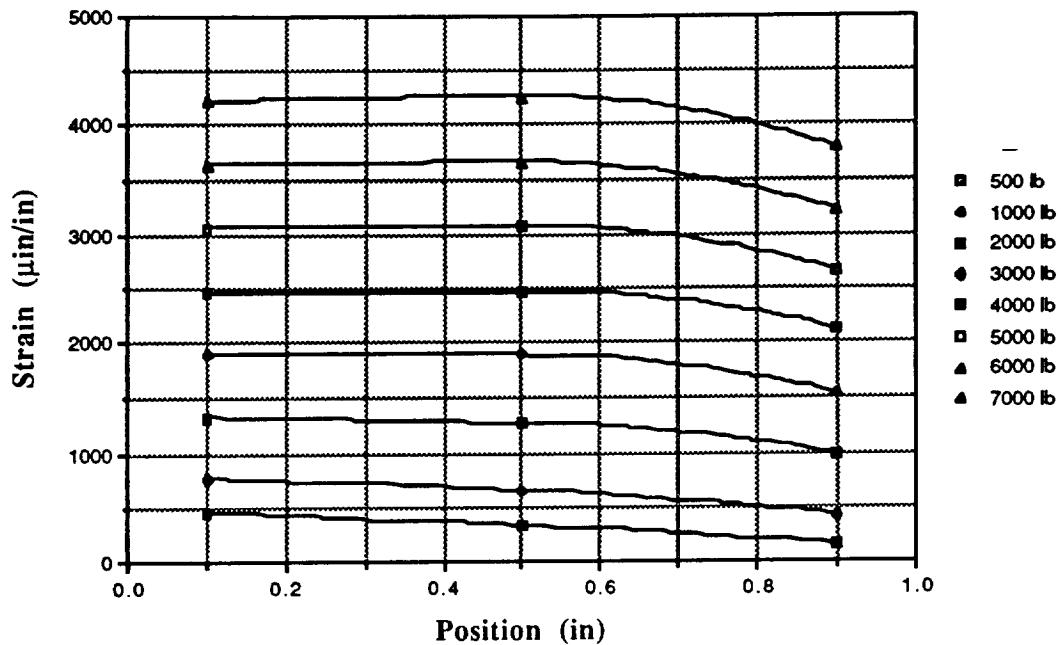
Figure 4.15 Strain Gage Readings Across Face Width (0.0004 in/in Misalignment)

4.15. This figure shows the gage readings for increasing loads from 500 to 9000 lbs. As can be seen from the figure, the loads on the left are slightly higher than those on the right. Because the 9310 gears were not crowned, this misalignment caused higher loads on the left side of the gear teeth. The first eight teeth tested showed fatigue failures initiating at the left edge when the failure surface was viewed under a 20x stereo microscope. Pressure sensitive paper was also placed between the upper anvil of the fixture and the gear tooth and this showed that the contact was heavier on the left side of the tooth.

The base of the fixture was then stone ground smooth and set on a Starrett grade B granite surface plate. A dial indicator was used to measure the alignment of the shaft. It was determined that the shaft had a misalignment of 0.0004 in/in which caused the heavy loading on the left side. Stainless steel shims of different thicknesses were placed under the left bearing block until the misalignment was reduced to less than 0.0001 in/in. At this point the strain gaged gear was again loaded and the results are shown in Fig. 4.16.

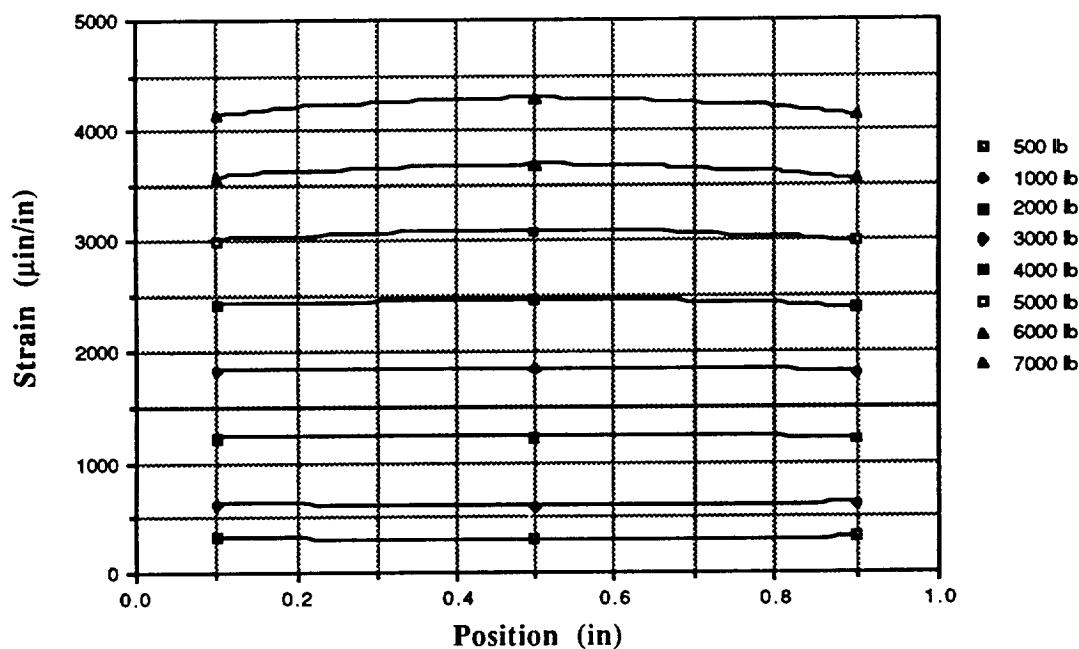
Figure 4.16 Strain Gage Readings Across Face Width (0.0001 in/in Misalignment)

Figure 4.16 shows that the load is now even across the tooth. The values of strain at the two edges are nearly identical at all loads. The strain in the middle of the tooth is slightly higher due to plane strain conditions in the center of the tooth and plane stress conditions at the edges. The remainder of the testing was carried out with the shims in place.

Further testing and microscopic examination of 6 teeth revealed that the cracks were initiating in the center of the teeth after the alignment was adjusted. This suggests that the fixture was aligned properly and no further alignment was needed. The fixture was checked periodically using this strain gaged gear and it was found that even with some wear on the anvils, the fixture alignment was satisfactory.

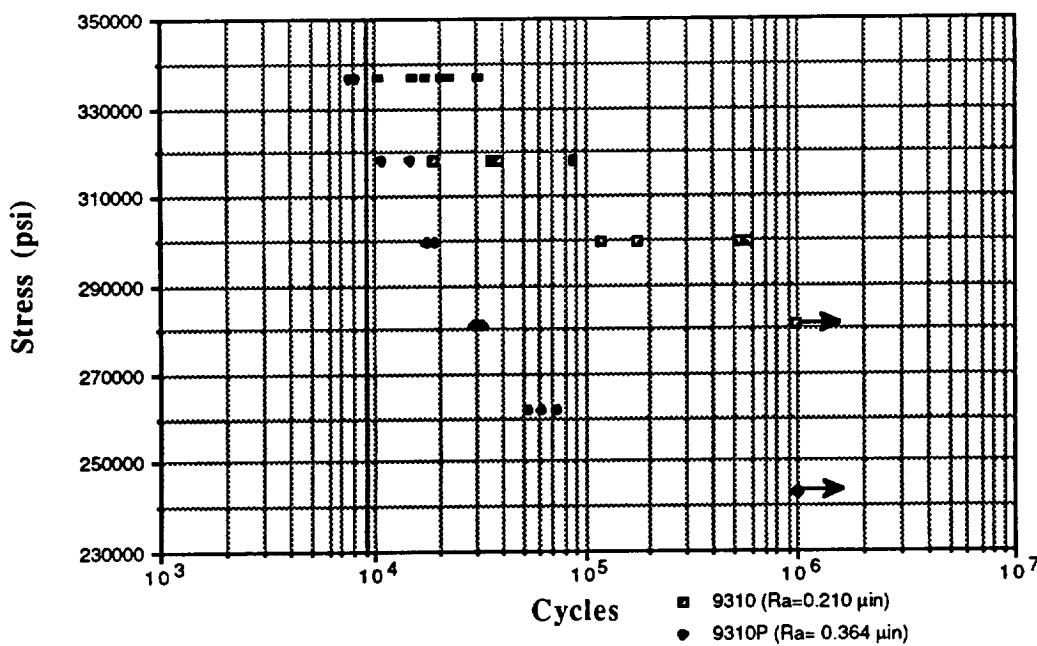
Figure 4.20 Fatigue Life Plot for 9310 Test Gears

One explanation for this behavior is that the shot peening process may have created microcracks at the surface which caused stress concentration areas and acted as initiation sites for fatigue cracks. The surface finish of materials has been shown to have a significant impact on the high-cycle fatigue life of machine parts; however, it has very little effect on the low-cycle fatigue or static strength of the part.. The fatigue lives of the peened and unpeened gears showed similar behavior in low cycle fatigue tests, suggesting that the surface may have been damaged by the peening process. More data is needed to determine the exact cause of the failures and the relative importance of the peening parameters on the bending fatigue resistance of carburized gear teeth.

Figure 4.20 shows the fatigue life of several 9310 steel gears that were manufactured exactly alike and heat treated in the same batch. Four of the gears was then shot peened. Rather peculiar results were obtained in this research. The fatigue life of the shot peened gears was significantly lower than that of the unpeened gears. The fatigue strength at root stresses of roughly 280 ksi. was reduced from a run-out at 10^6 cycles in the 9310 group to a failure at 3×10^4 cycles in the shot peened gears.

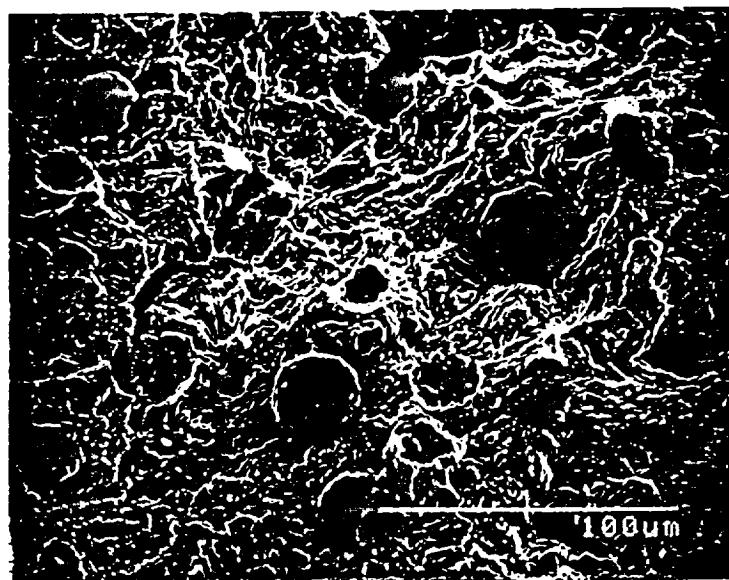
Figure 4.23 Scanning Electron Micrograph of ADI Gear Tooth (500x)

The ADI gear had fatigue lives comparable to the 8620 gears for fatigue stresses in the range of 170 to 220 ksi but as the load is lowered, and the high cycle fatigue effects are most prevalent, the ADI gear falls short of the 8620 in fatigue resistance. This can be explained by looking at the picture from the scanning electron microscope (SEM).
